UNDERWATER BRIDGE INSPECTION REPORT

STRUCTURE NO. 14511

RED RIVER OF THE NORTH

DISTRICT 4 - CLAY COUNTY, CITY OF MOORHEAD

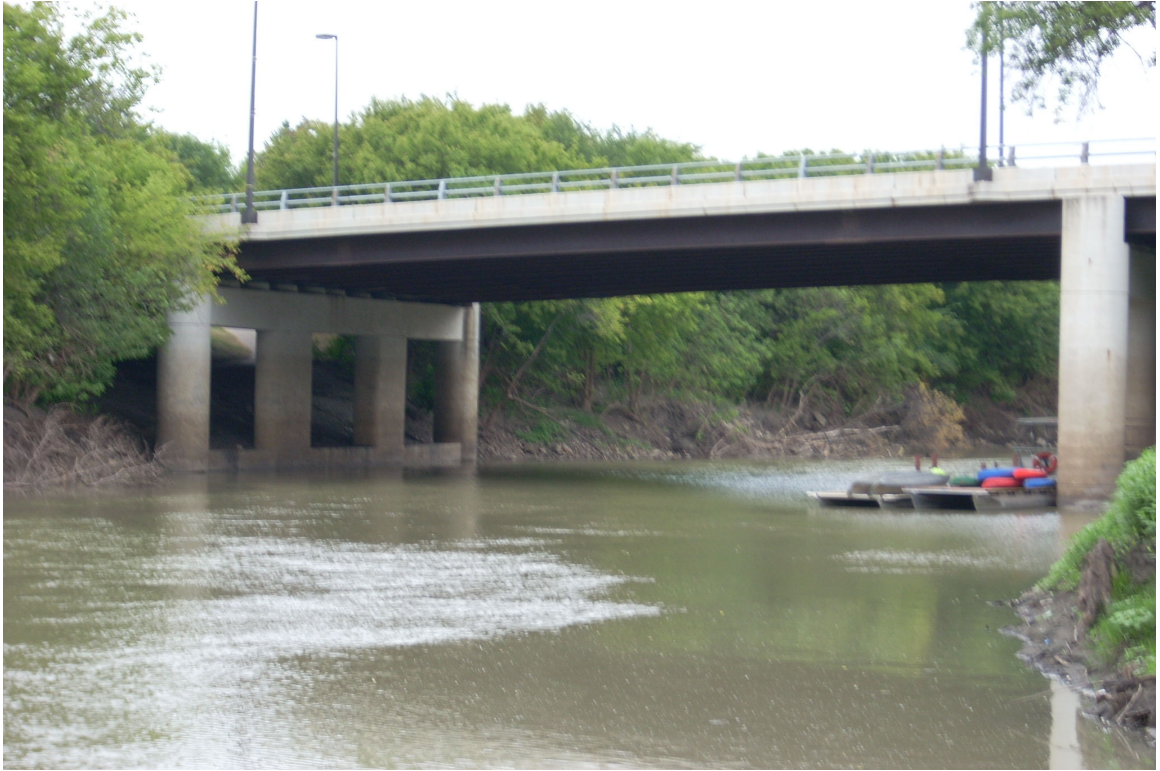
Photograph 1. Overall View of the Structure, Looking North.

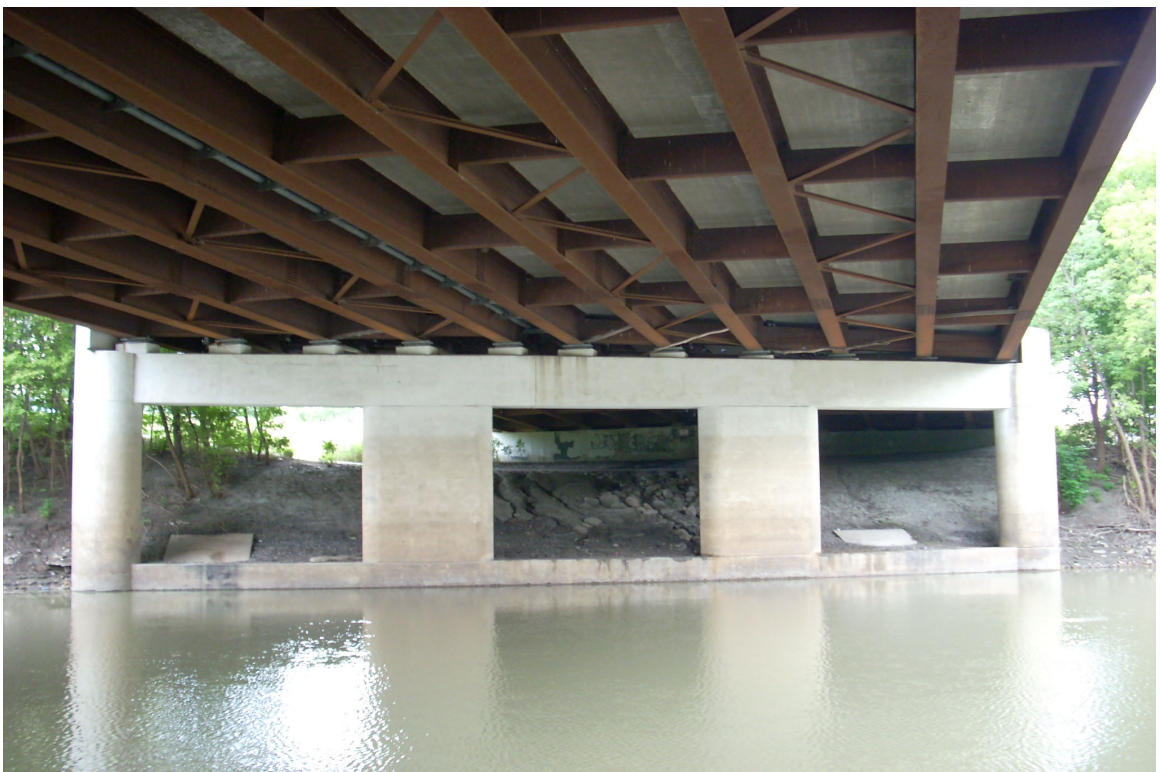
Photograph 2. View of Pier 3 and West Shore, Looking West.

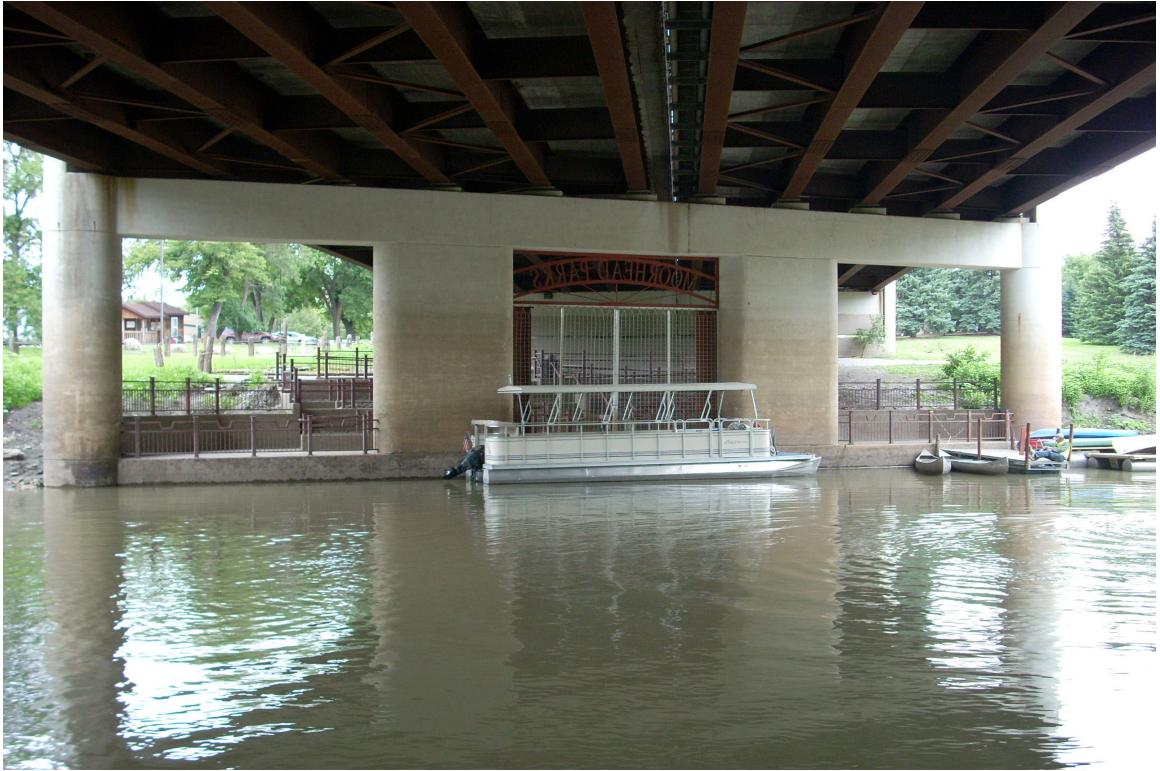
Photograph 3. View of Pier 4 and East Shore, Looking East.

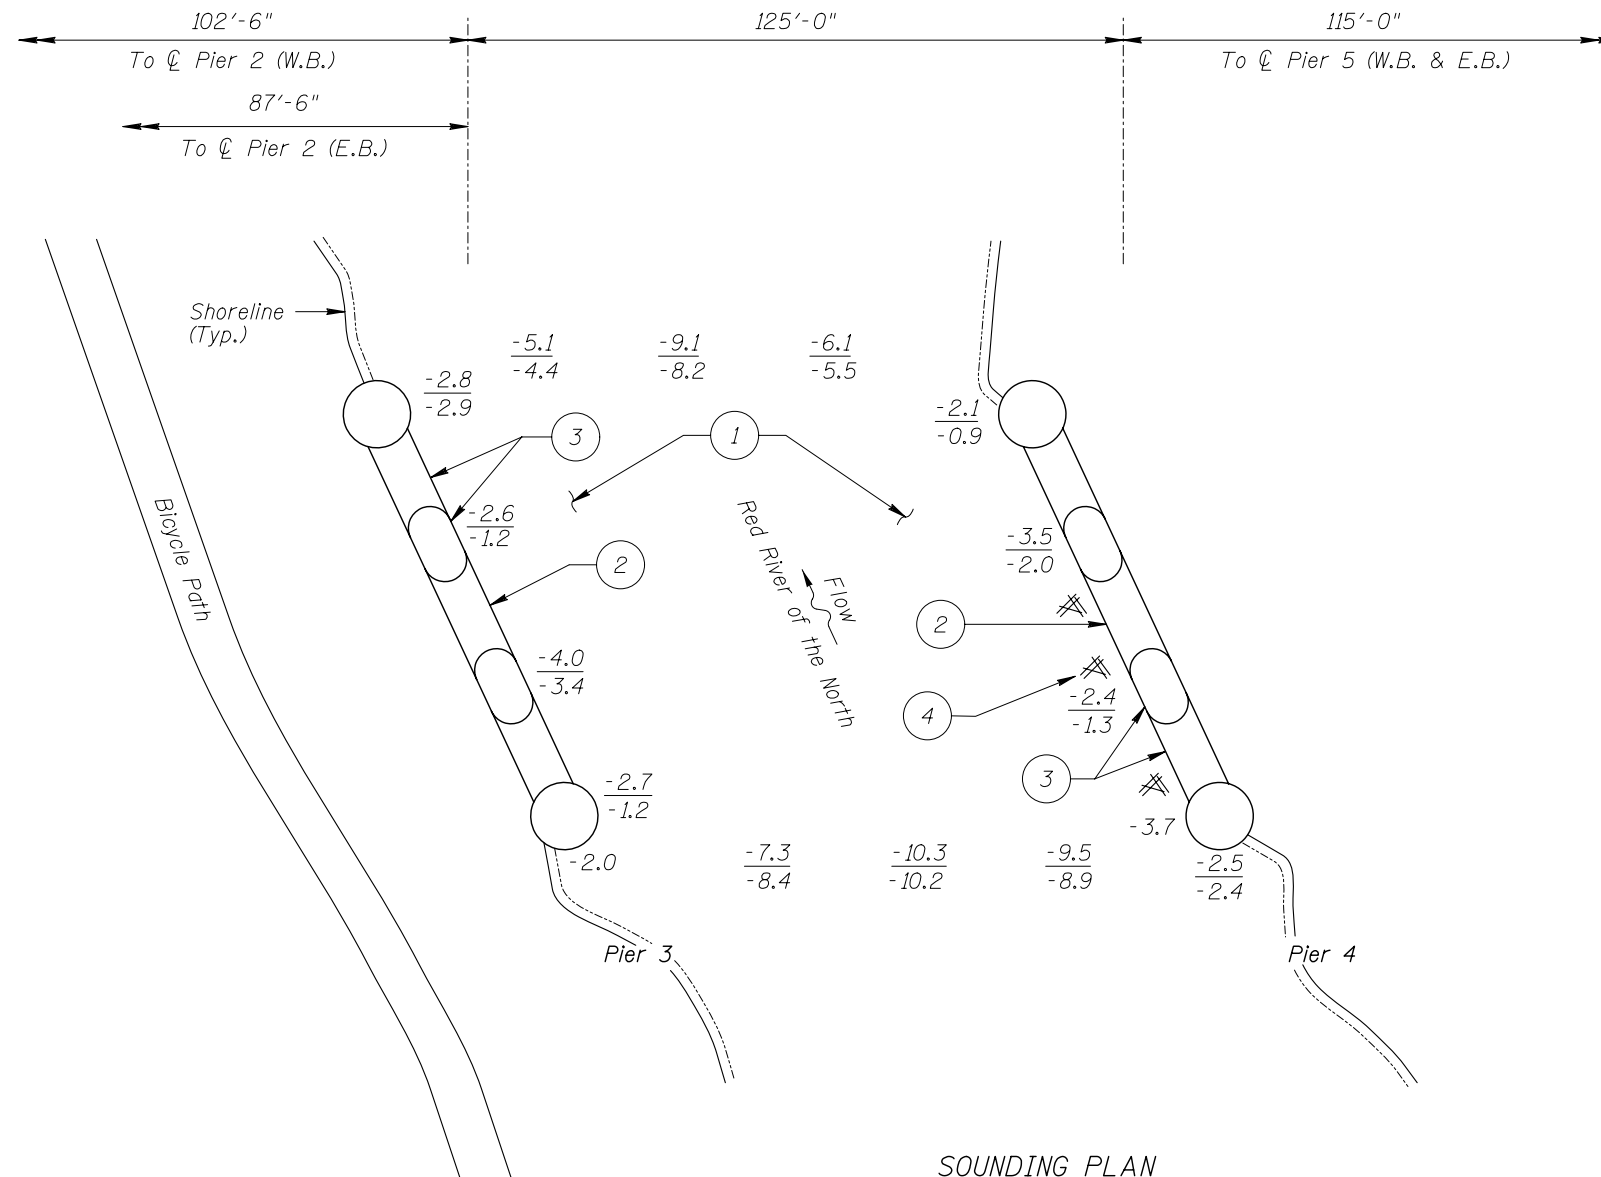
INSPECTION AND SOUNDING PLAN

- The channel bottom material consisted of soft clay and gravel with up to 1.5 feet of probe rod penetration.
- Random hairline to 1/16 inch wide vertical cracks were observed on the diaphragm wall of both piers, extending from the top of the diaphragm to the channel bottom.
- A minor accumulation of timber debris, consisting of 6 inch diameter and smaller branches, was observed along the west side of Pier 4 extending from the channel bottom up 1 foot and up to 4 feet off the pier face.
- The concrete of the columns and diaphragm wall of Piers 3 and 4 was typically smooth and sound.
